Docket No. 217 – Development and Management Plan Inspection

Northeast Utilities Service Company Certificate of Environmental Compatibility and Public Need for the construction of a 345-kV electric transmission line and reconstruction of an existing 115-kV electric transmission line between Connecticut Light and Power Company's Plumtree Substation in Bethel, through the towns of Redding, Weston, and Wilton, and to the Norwalk Substation in Norwalk, Connecticut.

Date: June 22, 2005

Location: 345 kV Underground Route

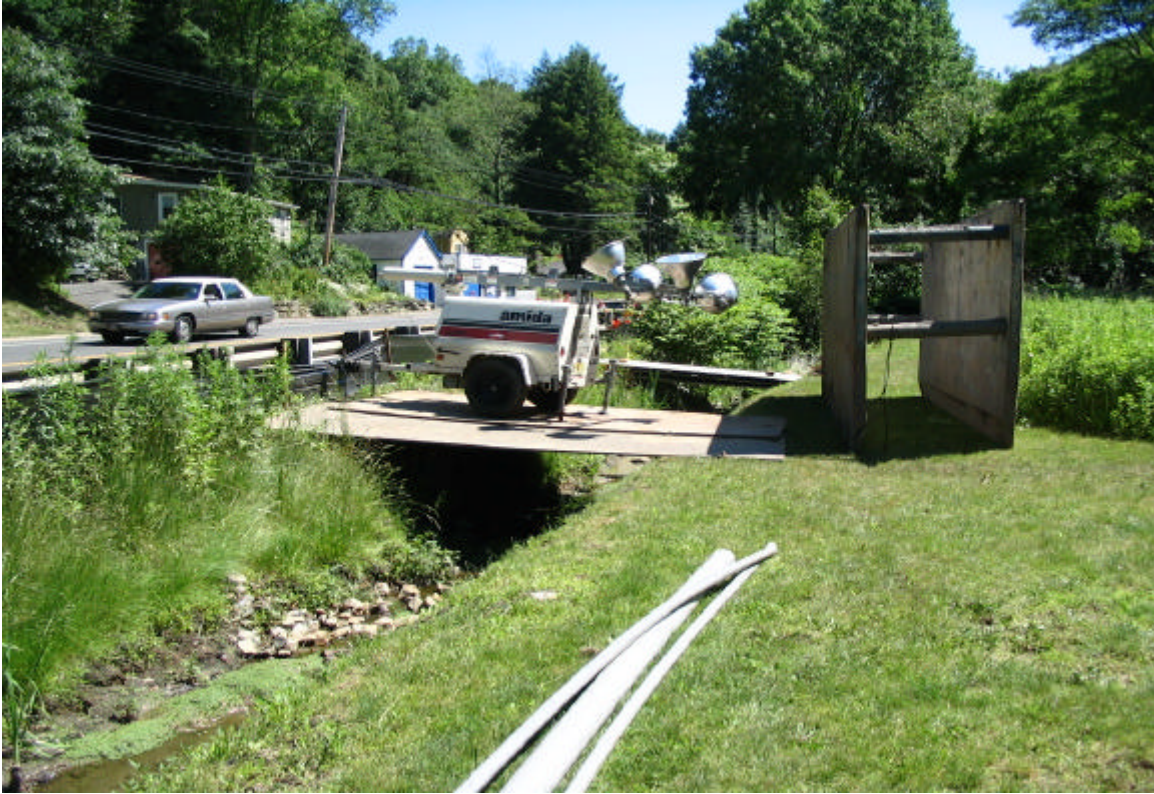
Trench work had occurred in the street near the storage area off Route 7 in Wilton. The light stand (and any other equipment) should be moved away from wetlands during inactive hours.
6/22/05

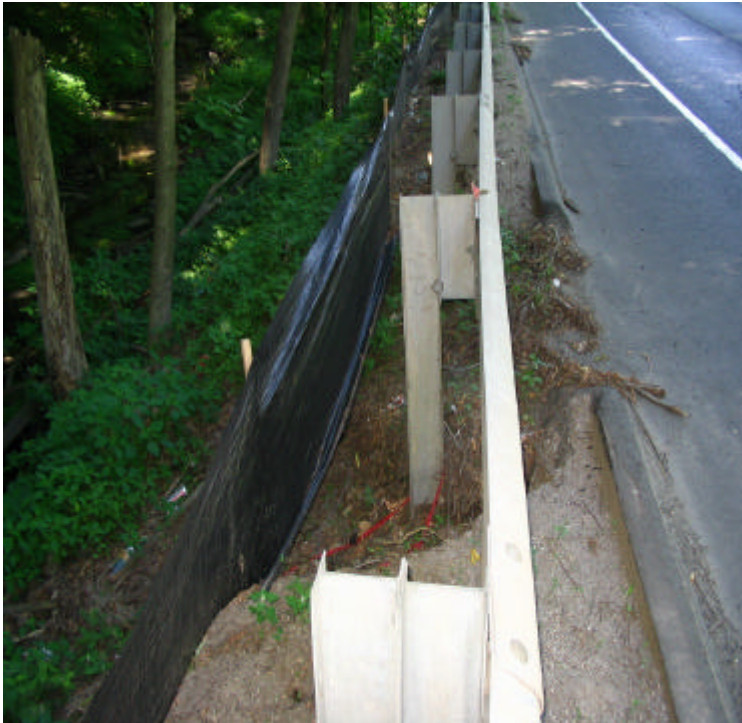
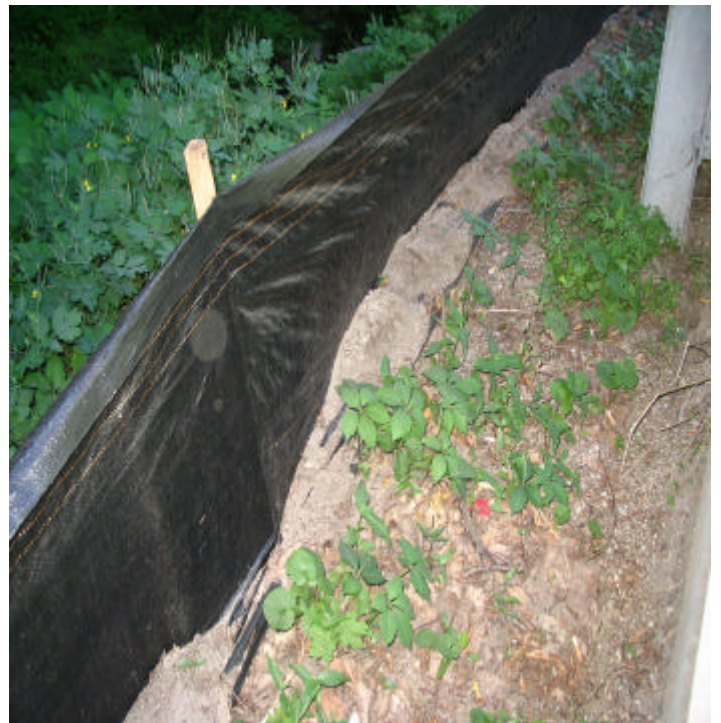
Area of silt fence along Route 7 signaled in the report. All silt fence should be toed into the ground several inches without remaining gaps. 6/22/05

Areas of Inspection	Observation	Recommended Action
Erosion and Sediment Controls (includes inspection within 24 hours of a storm event)	- Active work was moving in this direction and the silt fence should be repaired. 6/09-6/22/05	- Be sure to toe the bottom of the silt fence into the ground by several inches in all scenarios, otherwise it will not function as anticipated.

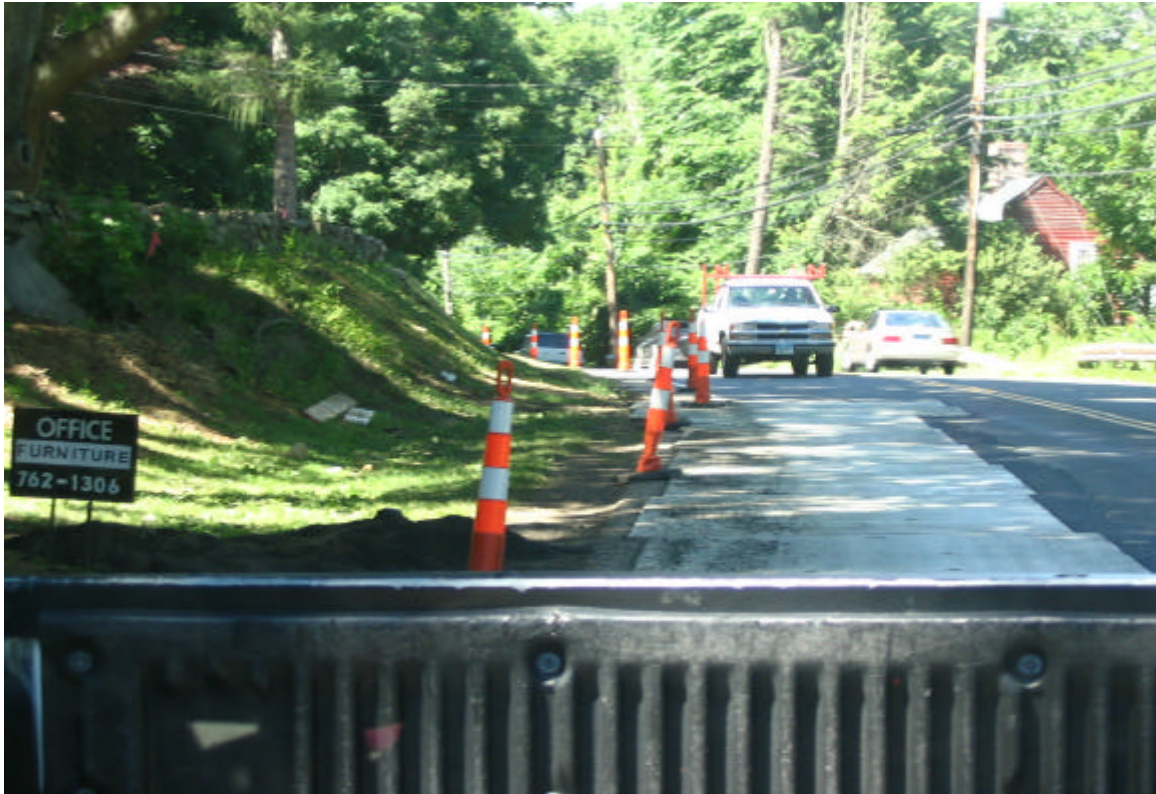
Additional area of trench work along Route 7. 6/22/05

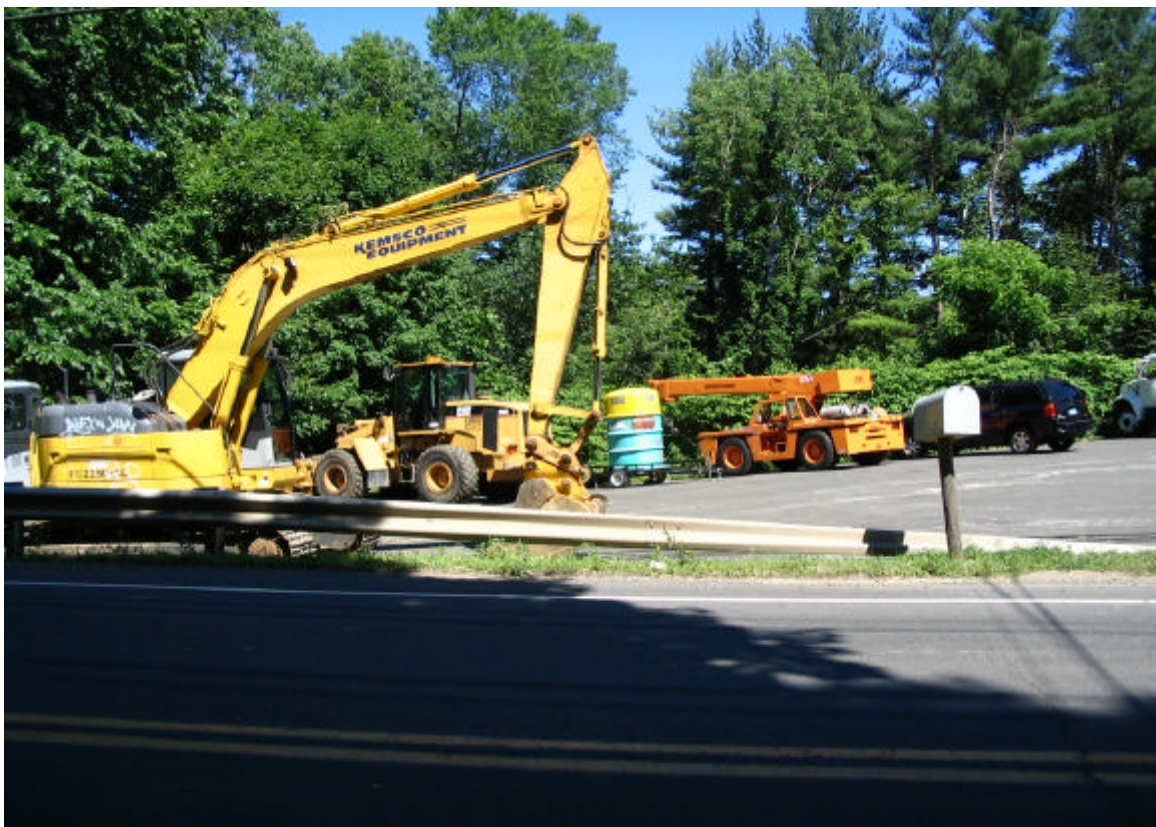
View of an equipment parking area near the recent trench work and in the lot of the United Methodist Church. 6/22/05
